Contract No. SDC/21.8.2/19  
Provision of Multi-Disciplinary Consultancy  
Services For The Proposed Deep Gravity Sewer  
Project at Sentosa

# **Environmental Study Final Report**

## ***Part II (Main Report)***

Submitted by:  
AECOM Singapore Pte Ltd

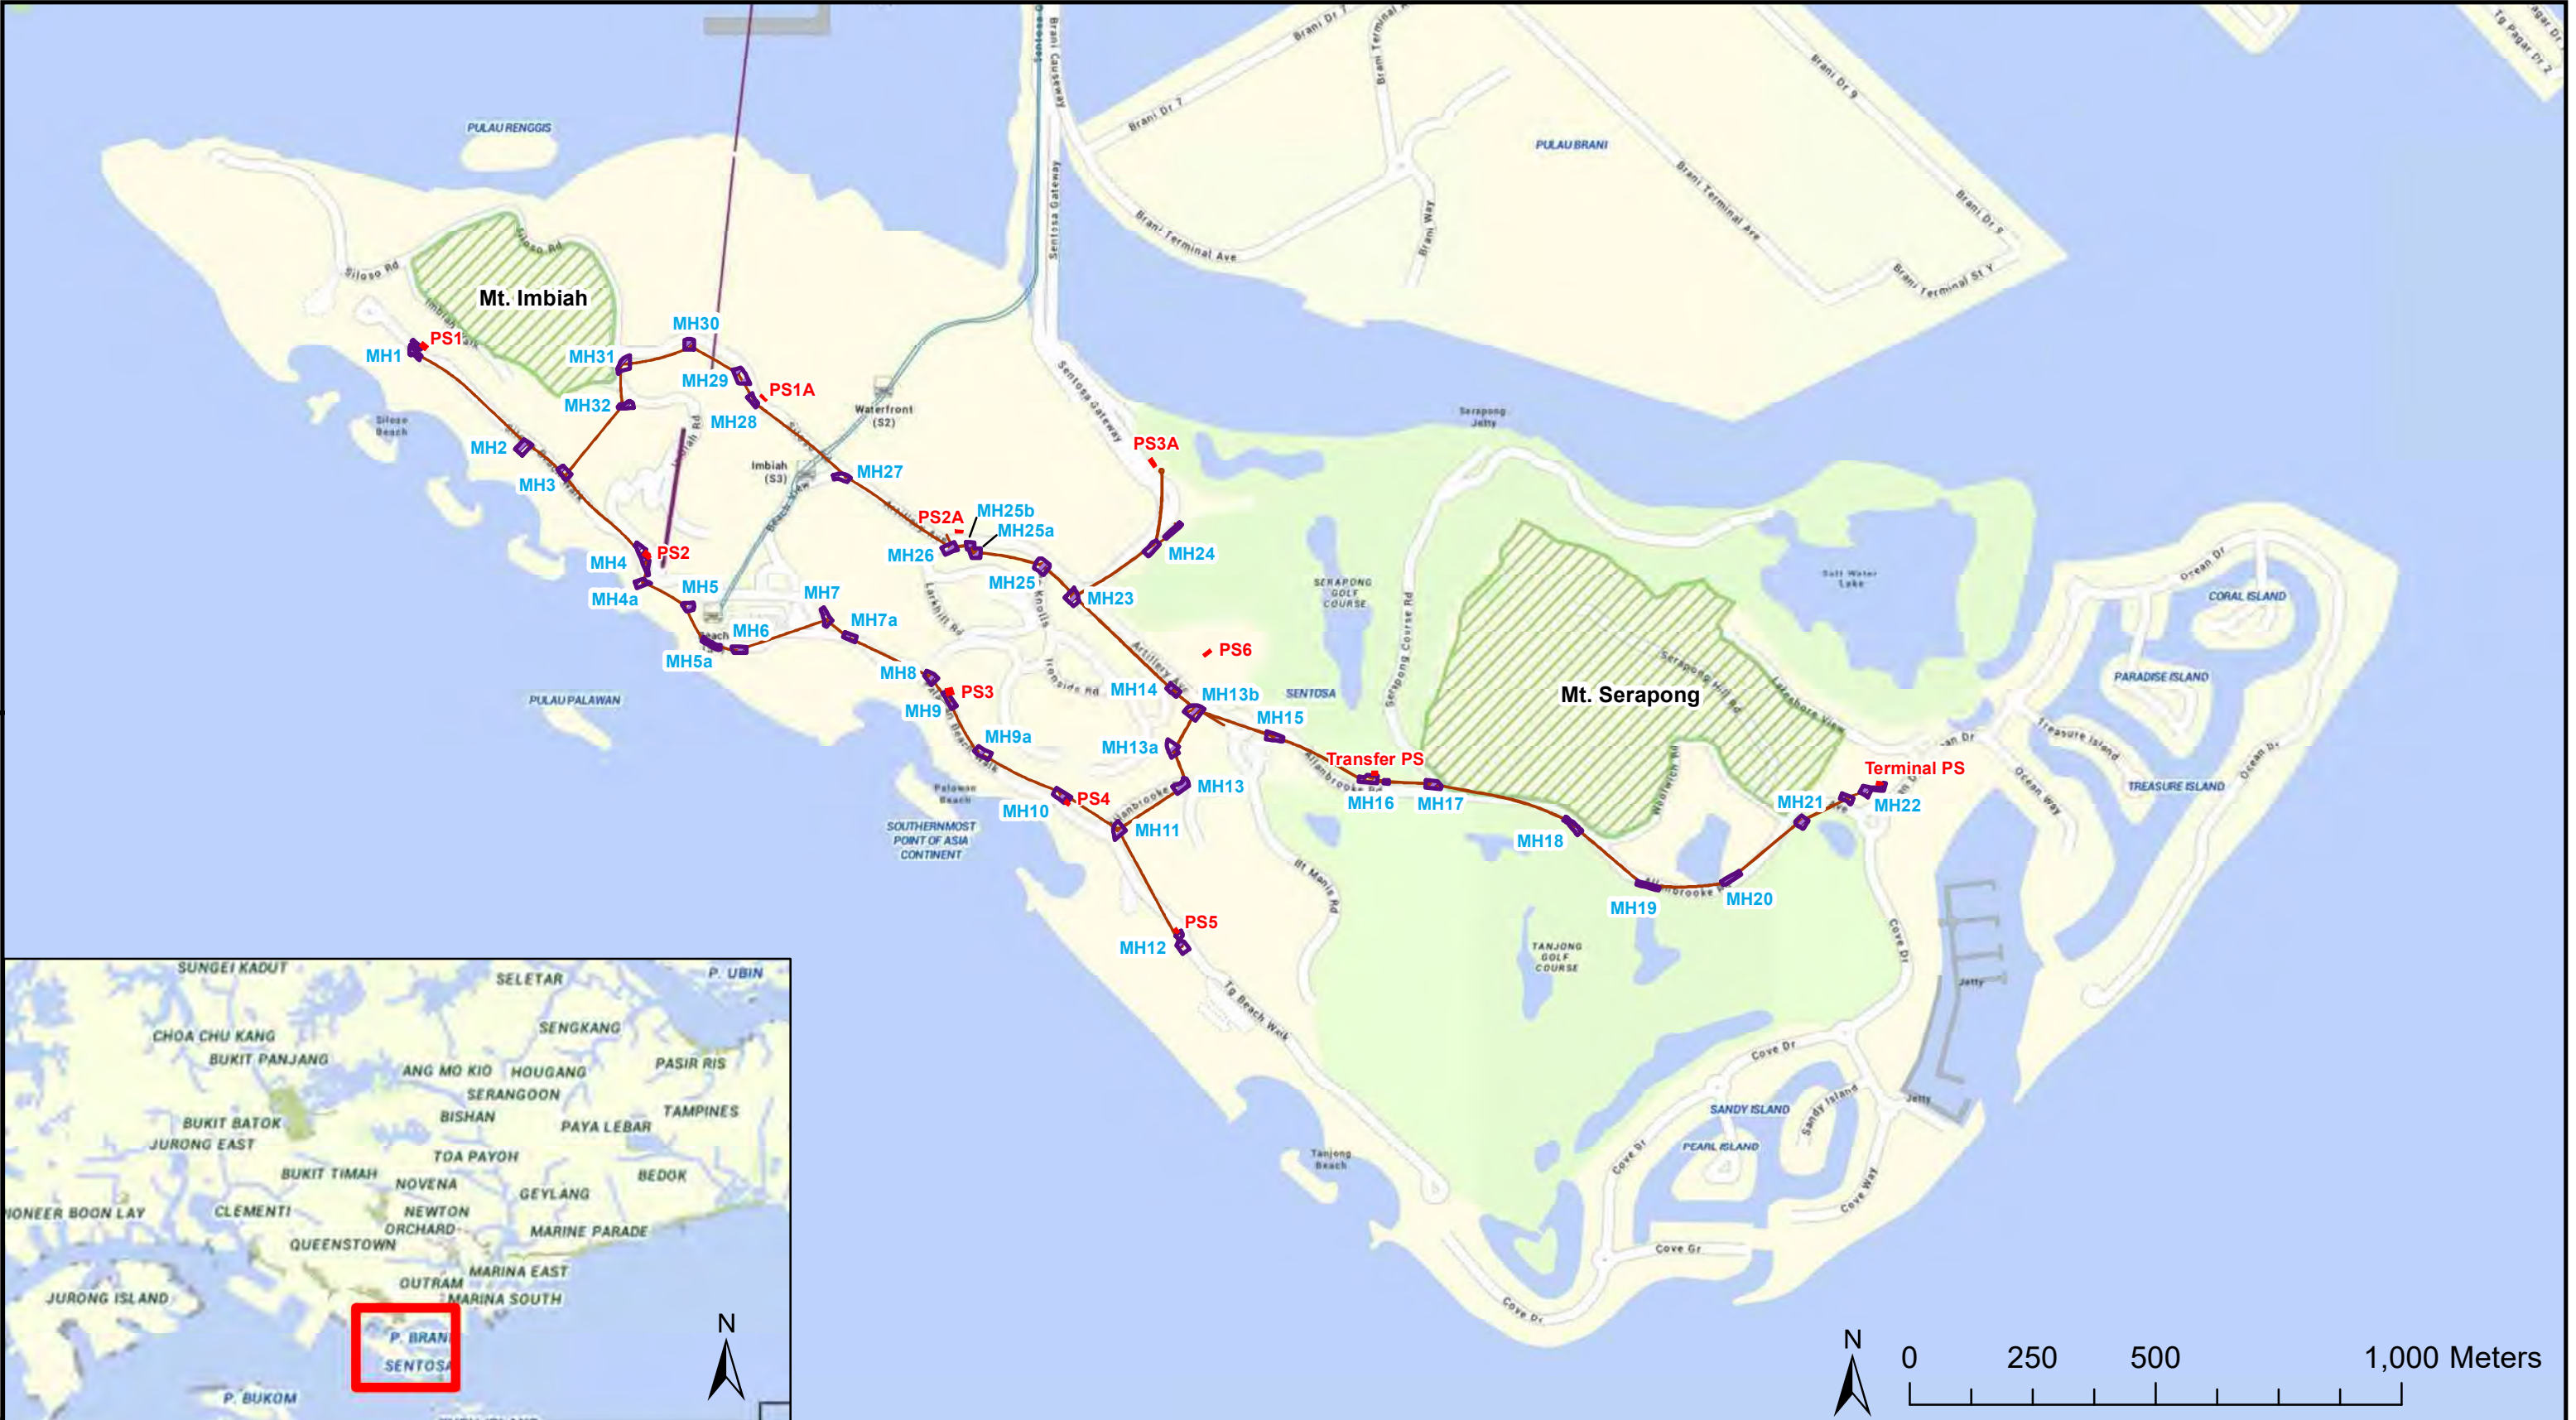
| | | | | | | | | Client Endorsement :<br>NA | Project Title :<br><b>Contract No. SDC/21.8.2/19:<br/>Environmental Study<br/>For The Proposed Deep Gravity<br/>Sewer Project at Sentosa</b> | | | Figure Title :<br><br><b>Project Overview</b> | | |

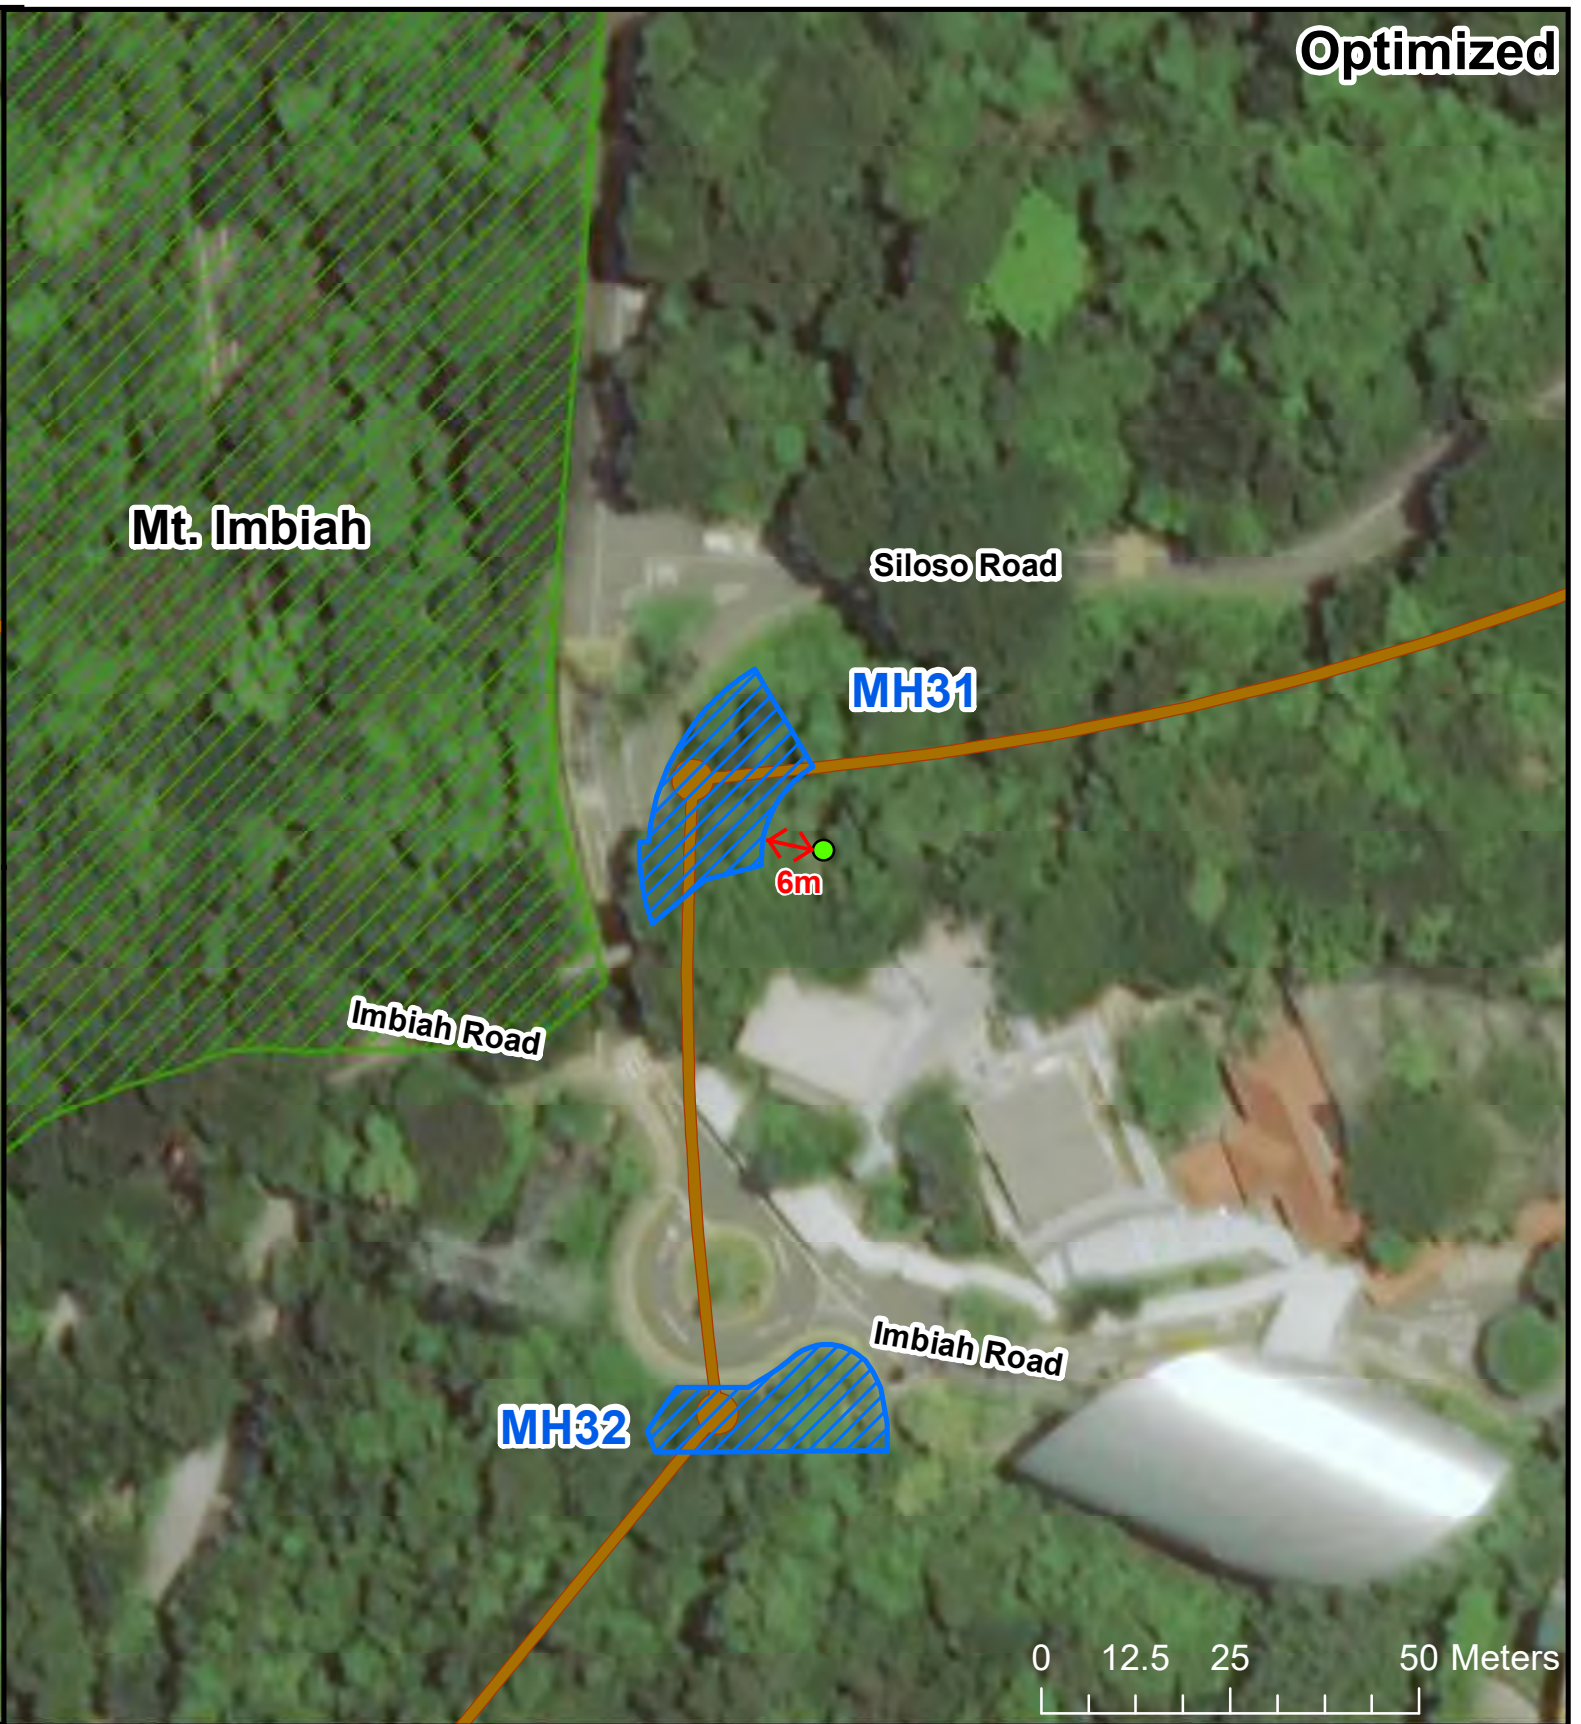
| | | | | | | | | | | | | Client Endorsement :<br>NA | Project Title :<br><div><div>Contract No. SDC/21.8.2/19:<br/>Environmental Study<br/>For The Proposed Deep Gravity<br/>Sewer Project at Sentosa</div></div> | | | Figure Title :<br><div><div>Design Optimization<br/>for MH31 Worksite</div></div> |

During this Environmental Study process, feedback was provided to the design engineers when the biodiversity specialist discovered a bamboo cluster with the presence of bamboo bats within the original MH31 worksite of approximately 600 m<sup>2</sup>. It was noted that Bamboo bats are nationally threatened in Singapore and are known to roost inside the internodes of bamboo branches. After multiple discussions with the design team, the MH31 worksite was optimized with a reduced footprint of 400 m<sup>2</sup>. This optimization was targeted to avoid felling of bamboo by setting up a Tree Protection Zone (TPZ) of 6 m radius from the centre of the bamboo cluster, therefore mitigating the biodiversity impact from the construction activities of this Project. The difference between the original and the optimized MH31 worksite was presented in Figure 3-2.

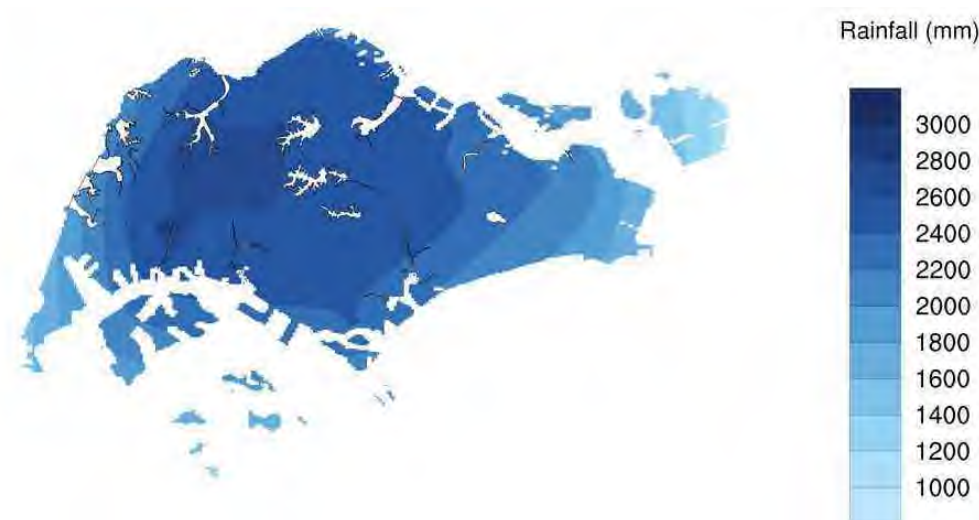
In terms of 30-years long-term average rainfall spatial distribution, rainfall was higher over the central and northern parts of Singapore and decreases towards the eastern and western parts of Singapore (Figure 4-9) [W-21]. For the southern part of Singapore where Sentosa island is located, it has higher rainfall than the eastern and western tips of Singapore, with relatively similar rainfall if compared to the central and northern parts of Singapore. Furthermore, the recent findings from MSS had shown an overall upward trend in total annual rainfall at increased average rates ranging from 3.3 to 12.2 mm/year, during the period from 1980 to 2019 (see Figure 4-10) if compared to the 30-years long-term basis, except for the areas near Changi and Queenstown climate stations at the east and south of Singapore respectively. [W-22]

Figure 4-9 Annual Average Rainfall Spatial Distribution (1981-2010) [W-21]

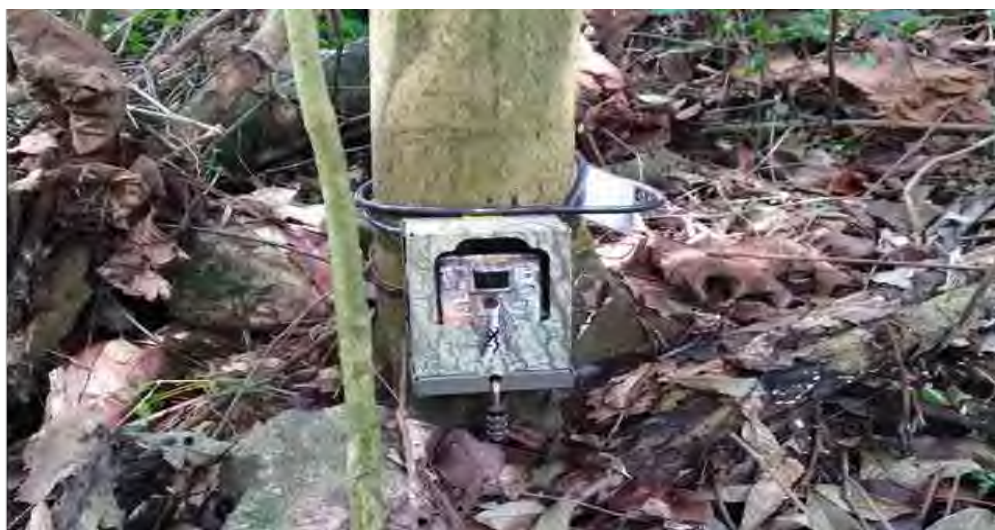
Each camera trap was set up at approximately 20–30 cm above ground (Figure 7-3). They were programmed to operate 24 hours a day and to record 10-second footage per motion trigger with a 10-second quiet period following each trigger. Each camera trap was deployed for 40 days. The camera trap model used was Browning Dark Ops HD Pro X BTC-6HDPX.

Figure 7-3 Camera Trap Set Up

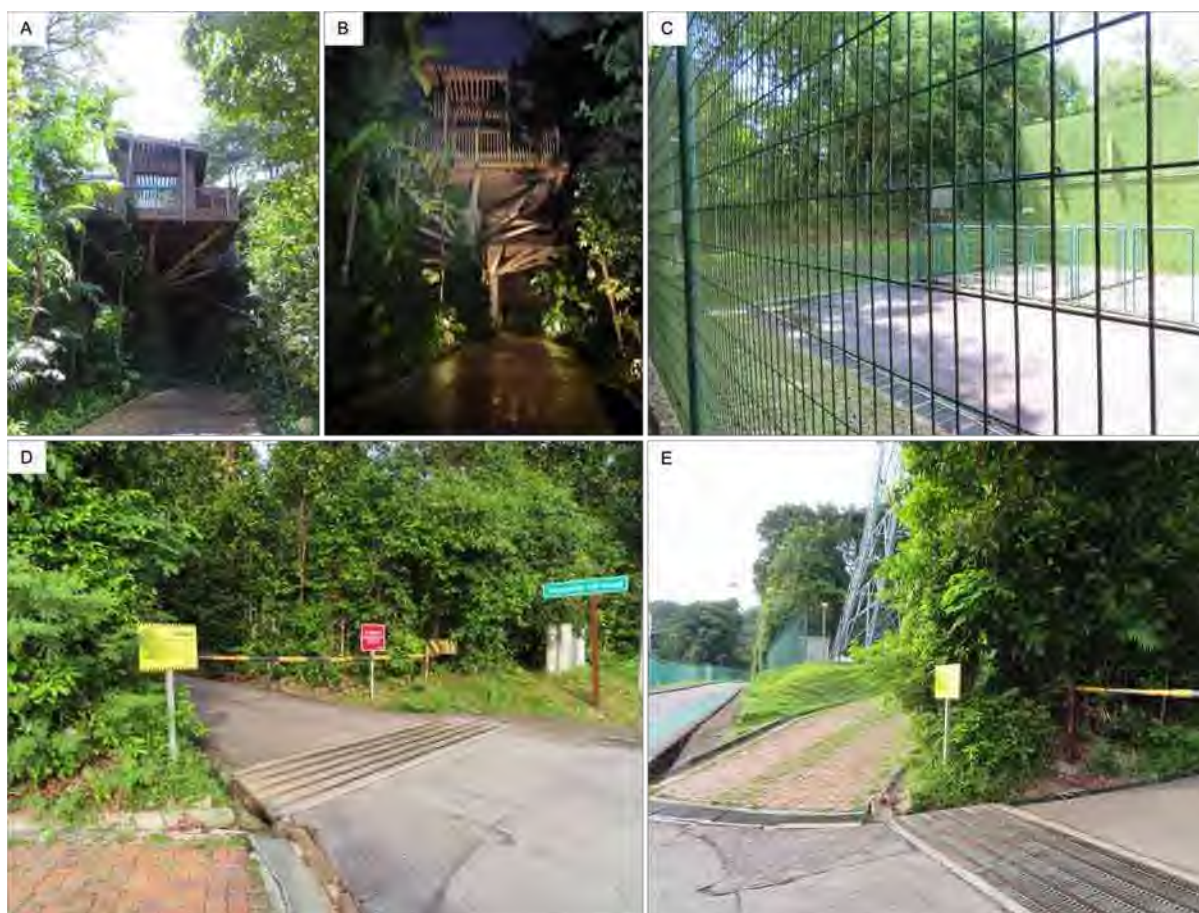
**Figure 7-13 Infrastructure in Both Study Areas. (A–B) TreeTop Lofts at the Mt. Imbiah Study Area in the Day and at Night, Respectively; (C–E) Facility Building, Roads and Transmission Tower, Respectively, in the Mt. Serapong Study Area**

At the Mt. Imbiah Study Area, infrastructure comprises Siloso Road that runs across its length, as well as the north eastern TreeTop Lofts (Figure 7-13A–B).

At the Mt. Serapong Study Area, more types of infrastructure are present across its two areas. These include a facility building, roads (i.e., a portion of Allanbrooke Road), residences (i.e., a part of Sentosa Cove), and a transmission tower (Figure 7-13C–E).

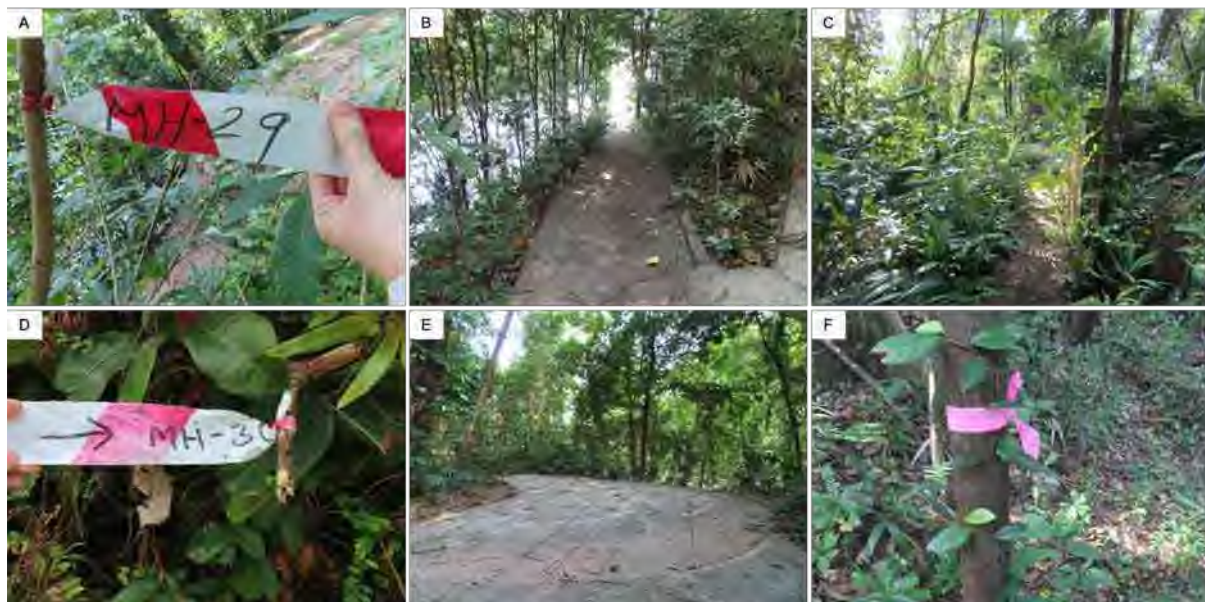
**Figure 7-23 Worksites for Manhole MH29 (A–C) and Manhole MH30 (D–F)**

None of the 13 specimens expected to be within the worksite for MH29 were found during ground-truthing. The area appears to be largely cleared (Figure 7-23B), presumably for the mini-golf course, and spontaneous vegetation have grown over (Figure 7-23C).

Similar to what was observed at the worksite for MH29, the trees at MH30 were also largely cleared and the ground covered by concrete. Of the 14 specimens expected to be within the worksite, only one was found during ground-truthing. Three other specimens in close proximity to but outside the worksite were also found (Figure 7-24). All four specimens were tagged with pink flagging tape (Figure 7-23F). The assessment of their suitability for transplantation was shown in Table 7-7.

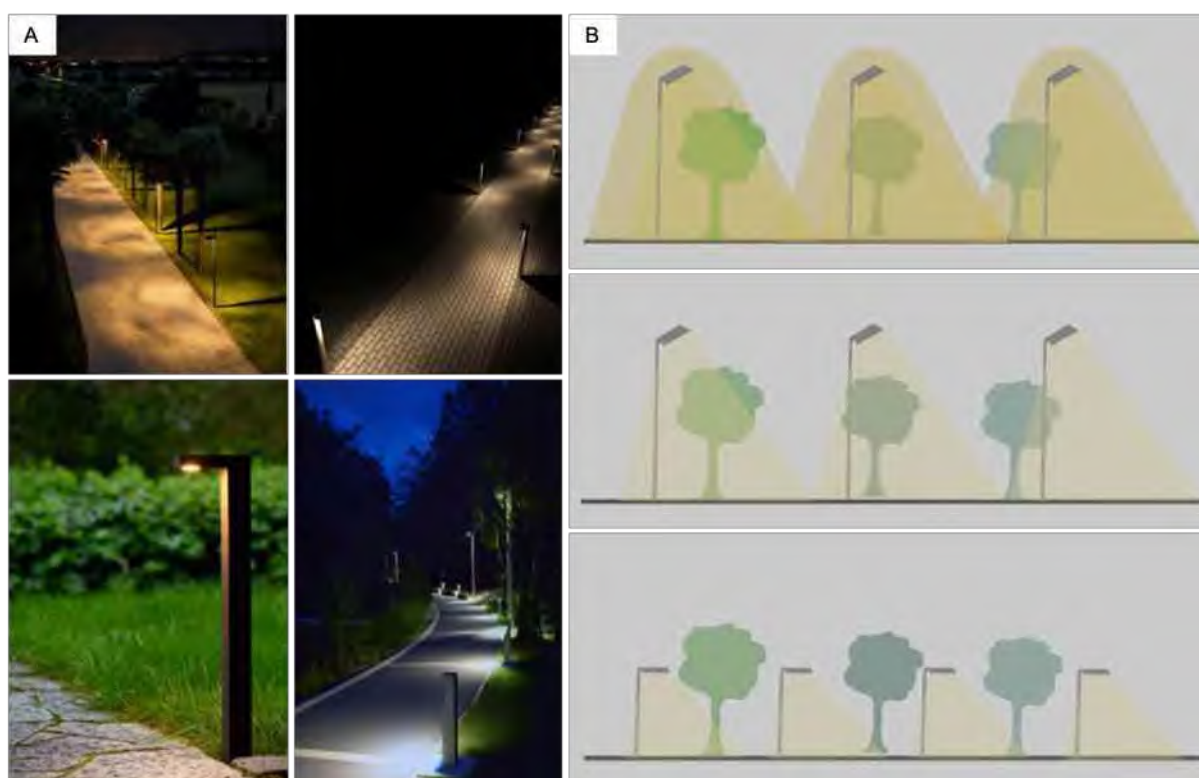
**Figure 7-41 (A) Low Level Bollards Directed downwards and Shielded to Limit Lighting to Only the Area Intended; (B) Combined Effects of Shielded Luminaires and Short Poles on Reducing Light Trespass (Top: Unshielded Luminaires; Middle: Luminaires with Shield; Bottom: Shielded Luminaires on Short Poles which Cut-Off Light Trespass and Keep Adjacent Areas Dark)**

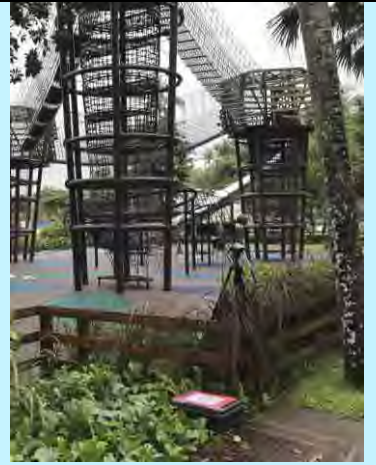
| Monitoring Location | Nearest Construction Worksite Area | Sensitivity of Receptor at Monitoring Location | | Justification | Photo of Monitoring Location |
|---|---|---|---|---|---|
| <b>NM01: Near Nestopia at Siloso Beach Walk</b> | MH1 Worksite (Mt. Imbiah) | Priority 1, 2, 3 (dependent on species sensitivity) | Commercial & Residential | <p>The area near Nestopia at Siloso Beach Walk was selected as a representative baseline noise monitoring location for the beach environment along Sentosa's beaches, where the proposed MH1 worksite would be located nearby.</p> <p>The purpose of assessing the baseline noise levels at this location was to determine the noise criteria for noise impact assessment of proposed worksites located in a similar beach environment at the west-southern side of Sentosa Island.</p> | |

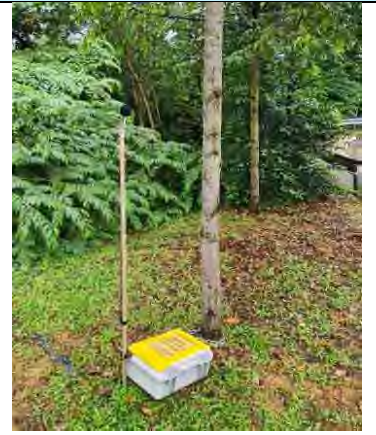
| Monitoring Location | Nearest Construction Worksite Area | Sensitivity of Receptor at Monitoring Location | | Justification | Photo of Monitoring Location |
|---|---|---|---|---|---|
| <b>NM02: Near Imbiah Lookout Station at Sentosa Island</b> | MH32 Worksite (Mt. Imbiah) | Priority 1, 2, 3 (dependent on species sensitivity) | Commercial & Residential | <p>The area opposite to the Imbiah Lookout Station was selected as a representative baseline noise monitoring location of the natural environment and human activities near Mt. Imbiah, where the MH32 worksite would be located nearby.</p> <p>The purpose of assessing the baseline noise levels at this location was to determine the noise criteria for noise impact assessment of proposed worksites near both natural environment and entertainment facilities at the western side of Sentosa Island.</p> | |

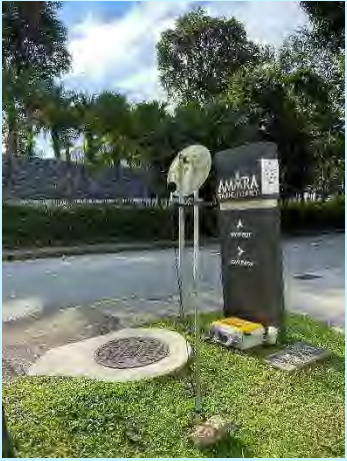
| Monitoring Location | Nearest Construction Worksite Area | Sensitivity of Receptor at Monitoring Location | | Justification | Photo of Monitoring Location |
|---|---|---|---|---|---|
| <b>NM03: Near Amara Sanctuary Resort Sentosa</b> | MH26 Worksite | NA. | Commercial & Residential | <p>The area near the road entrance to the Amara Sanctuary Resort was selected as a representative baseline monitoring location of the hotel area (e.g. The Barracks Hotel, Village Hotel, Outpost Hotel) in the central of Singapore where entertainment facilities (e.g. Universal Studios Singapore, etc.) were in the vicinity. The nearest construction worksites would be the proposed MH25a, MH25b and MH26 worksites.</p> <p>The purpose of assessing the baseline noise levels at this location was to determine the noise criteria for noise impact assessment of proposed worksites under a mixed development environment dominated by short-term residential and entertainment activities in the central of Sentosa Island.</p> | |

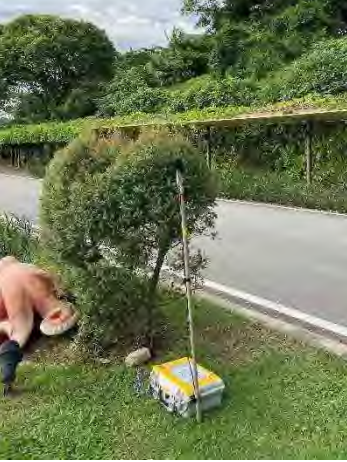
| Monitoring Location | Nearest Construction Worksite Area | Sensitivity of Receptor at Monitoring Location | | Justification | Photo of Monitoring Location |
|---|---|---|---|---|---|
| <b>NM04: Near Palawan Beach and Opposite Capella Singapore</b> | MH10 Worksite | NA. | Commercial & Residential | <p>The area along Palawan Beach Walk with Capella Singapore overlooking the area from above was chosen as a representative baseline noise monitoring location for the beach environment along Sentosa's beaches, where the proposed MH10 worksite would be located nearby.</p> <p>The purpose of assessing the baseline noise levels at this location was to determine the noise criteria for noise impact assessment of impacts arising from construction works at MH10 to the residents in Capella Singapore. This could also serve as a reference for other worksites along the southern beaches in Sentosa Island.</p> | |

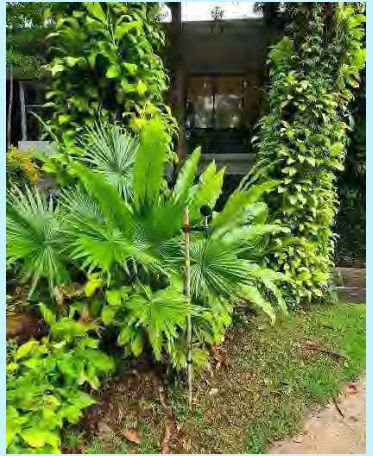
| Monitoring Location | Nearest Construction Worksite Area | Sensitivity of Receptor at Monitoring Location | | Justification | Photo of Monitoring Location |
|---|---|---|---|---|---|
| <b>NM05: At roadside behind Islander Pre-School</b> | MH15 and MH16 Worksite (Mt. Serapong) | Priority 1, 2, 3 (dependent on species sensitivity) | Commercial & Educational Institution | <p>The area behind Islander Pre-School was chosen as a representative baseline noise monitoring location within the study area due to the nature of the establishment and its proximity to MH15 and MH16 worksites.</p> <p>The purpose of assessing the baseline noise levels at this location was to determine the noise criteria for noise impact assessment of impacts arising from construction works from the proposed worksites on receptors of educational uses.</p> | |

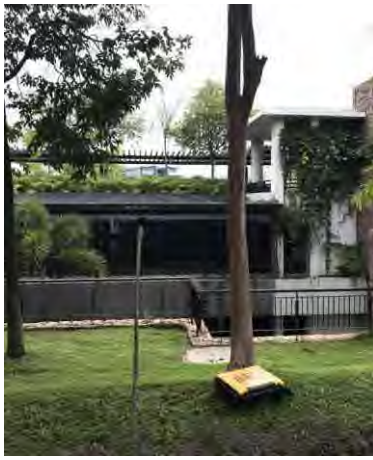
| Monitoring Location | Nearest Construction Worksite Area | Sensitivity of Receptor at Monitoring Location | | Justification | Photo of Monitoring Location |
|---|---|---|---|---|---|
| <b>NM06: Opposite Lakeshore View residence along Ocean Drive and near Sentosa Cove Village Car Park</b> | MH22 Worksite (Mt. Serapong) | Priority 1, 2, 3 (dependent on species sensitivity) | Commercial & Residential | <p>The area near Lakeshore View residence was chosen as a representative baseline noise monitoring location for the residential-dominant development (e.g. Sentosa Cove houses, shops and recreational facilities, etc.) at the eastern side of Sentosa, where the proposed MH22 worksite would be located nearby.</p> <p>The purpose of assessing the baseline noise levels at this location was to determine the noise criteria for noise impact assessment of proposed worksites under a mixed development environment dominated by long-term residential and recreational activities in the eastern side of Sentosa Island.</p> | |

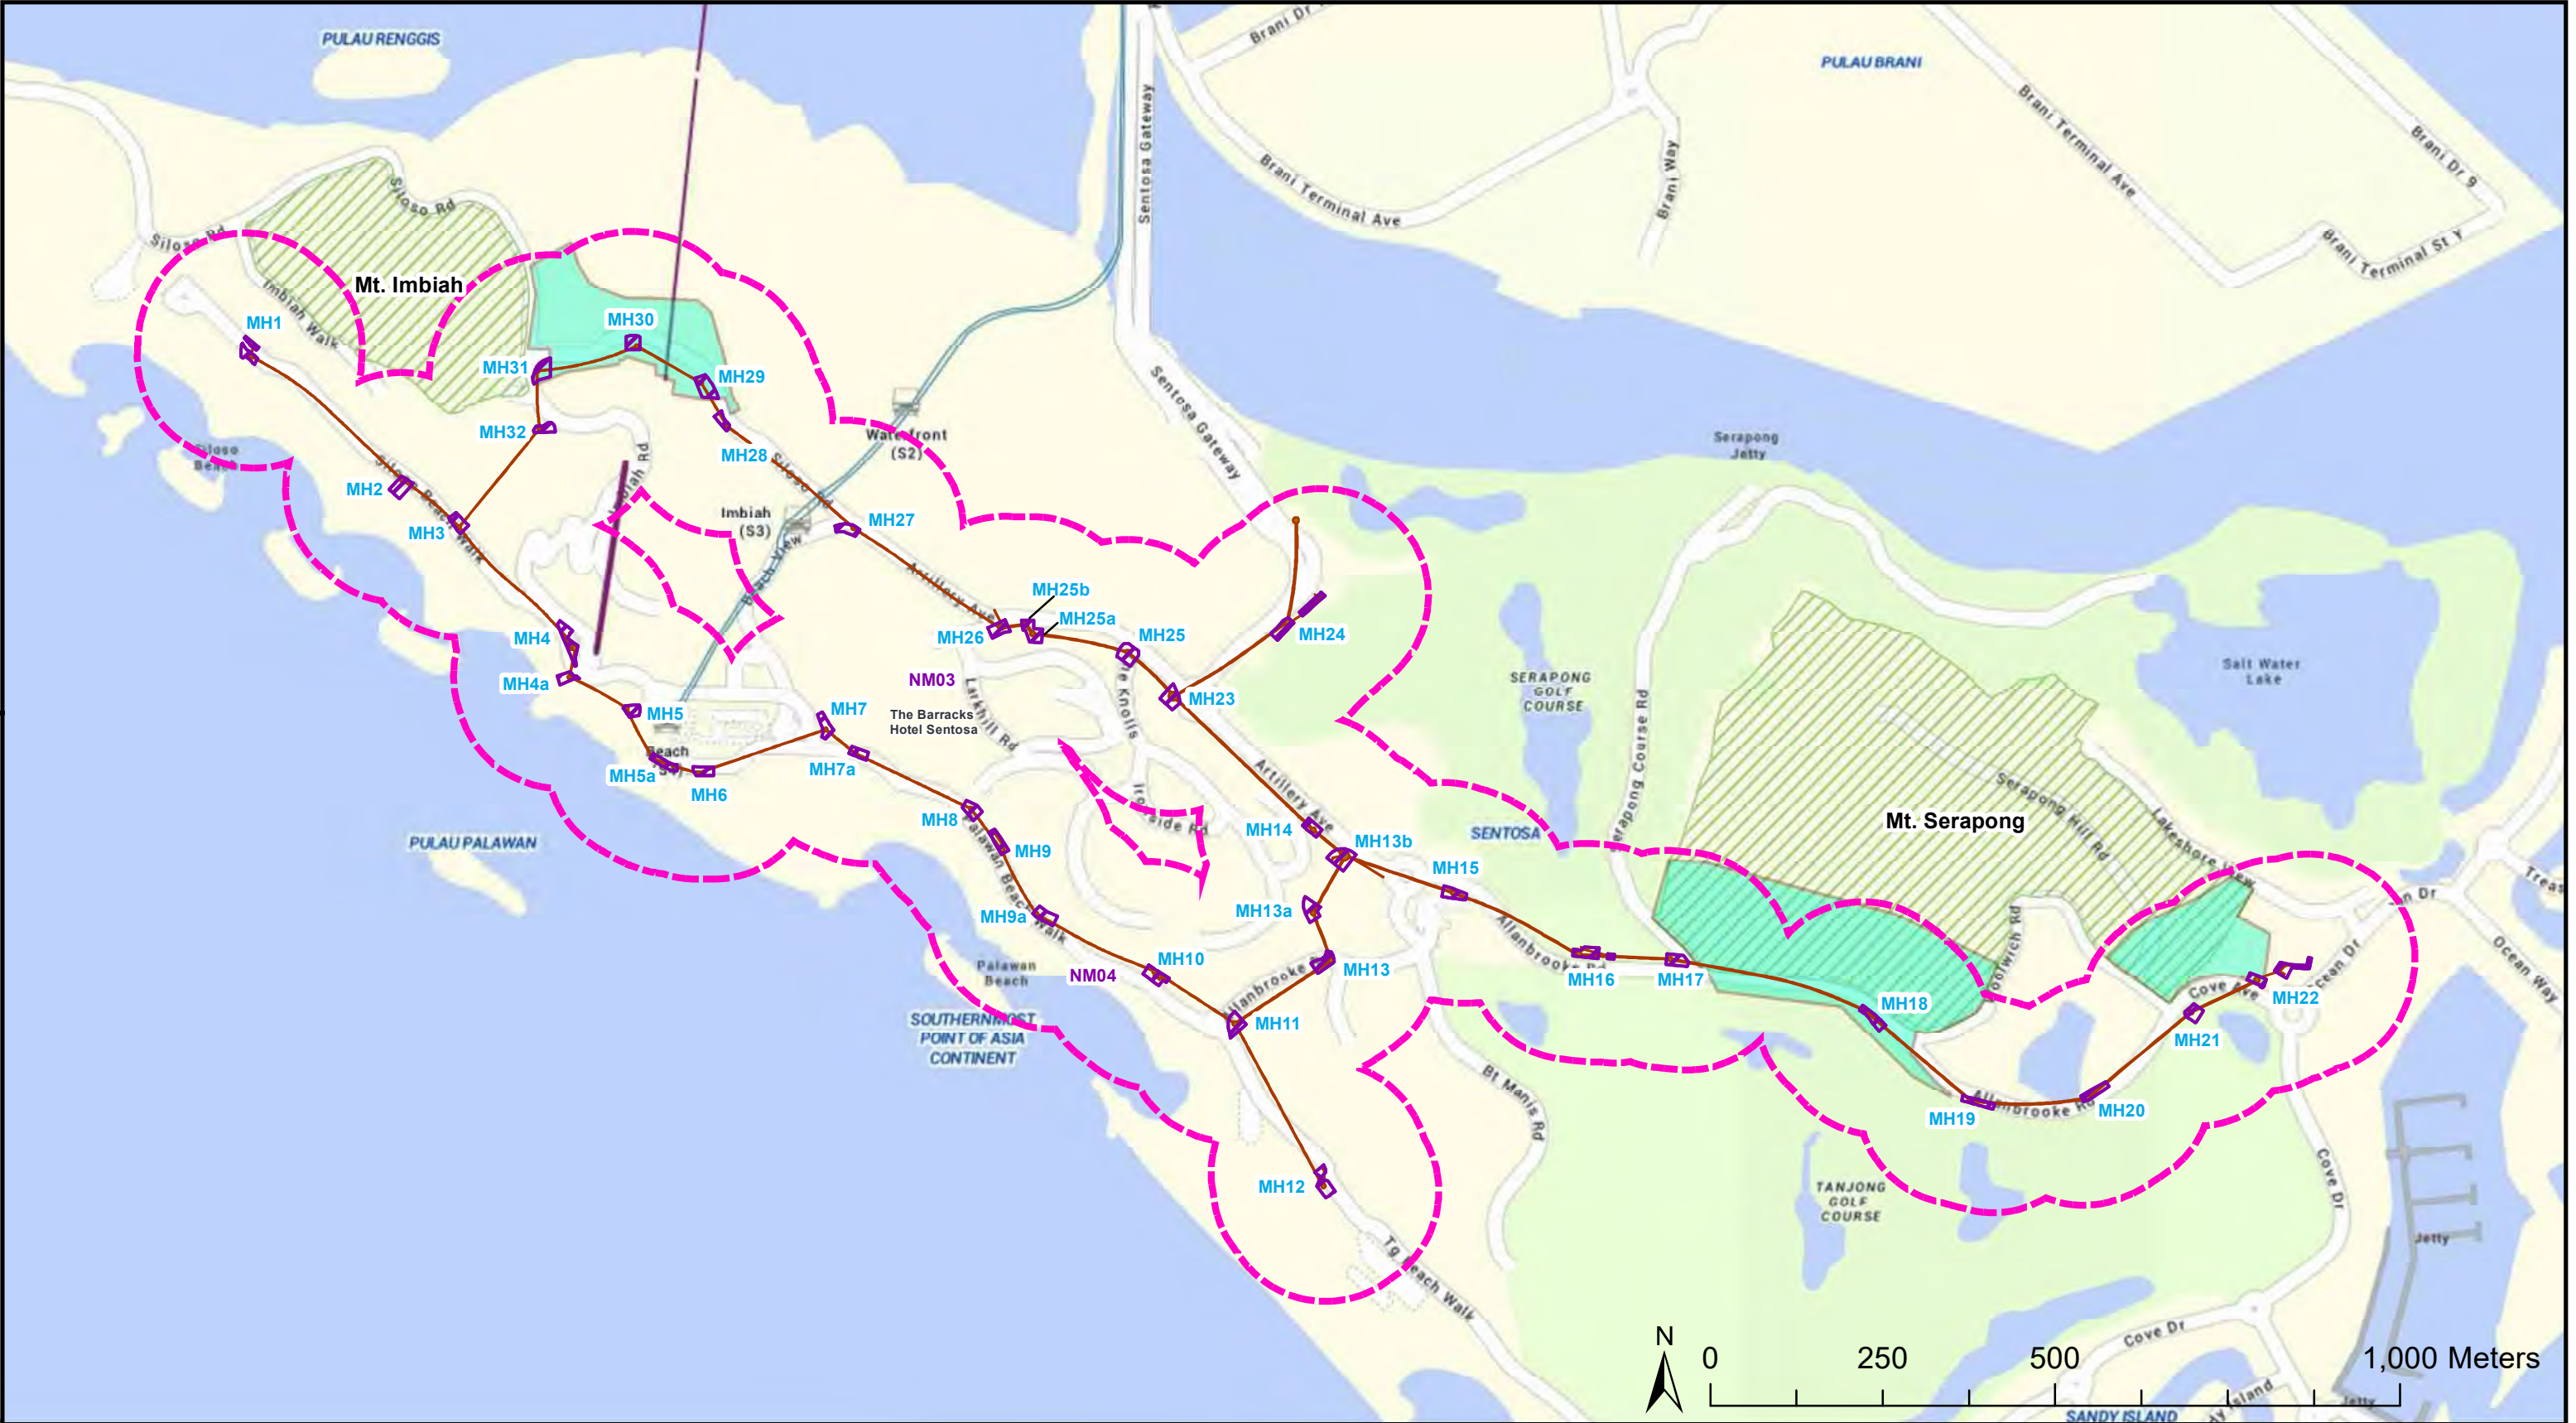
| <div><div>Legend</div><div><div><div></div></div>Base Construction Worksites</div><div><div><div></div></div>DGS Manholes &amp; Pipeline</div><div><div><div></div></div>Nature Areas</div><div><div><div></div></div>Biodiversity Study Area for Mt. Imbiah and Mt. Serapong</div><div><div><div></div></div>Study Area (150m)</div></div> | | | | | | | Qualified Person Endorsement :<br>NA | <div>Consultant :<br/><div>AECOM</div></div> | <div>Project Title :<br/><b>Contract No. SDC/21.8.2/19:<br/>Environmental Study<br/>For The Proposed Deep Gravity<br/>Sewer Project at Sentosa</b></div> | | | <div>Figure Title :<br/><b>Airborne Noise Sources<br/>- Construction Phase</b></div> | | | |

| Scenario/ Worksite | Effective Sound Power Level $L_{wA}$ , dB(A) used in the Noise Model | | | | | | | |
|---|---|---|---|---|---|---|---|---|
| All Construction Worksites<br>(see <b>Figure 8-3</b> ) | 110 | | NA. | | | 116 | | |

| Worksites | Construction Activities and Duration | Likelihood |
|---|---|---|
| All Construction Worksites<br>(see Figure 8-3) | <p>The Total Construction Timeline is 51 months (based on the tentative schedule in Section 3.4).</p> <p>Construction of Proposed DGS System for <math>L_{Aeq}</math> (12 hour), <math>L_{Aeq}</math> (1 hour), and <math>L_{Aeq}</math> (5 min) for <b>7am – 7pm, 7pm – 7am, 7pm – 10pm and 10pm – 7am</b> include the following key activity with estimated period required at each worksite:</p> <ul style="list-style-type: none"> <li>• Pipe Jacking – 3 months</li> </ul> | <p>Likelihood of Occurrence of Construction Activities for <math>L_{Aeq}</math> (12 hour), <math>L_{Aeq}</math> (1 hour) and <math>L_{Aeq}</math> (5 min) (7am – 7pm (excluding Weekdays), 7pm – 10pm, 10pm – 7am) – approximately 5.8%.</p> <p><b>Likelihood:</b><br/><b>Less Likely/ Rare</b><br/>(see Table 6-6)</p> |
